Chapter 1

Causes of Power Transformer Failure

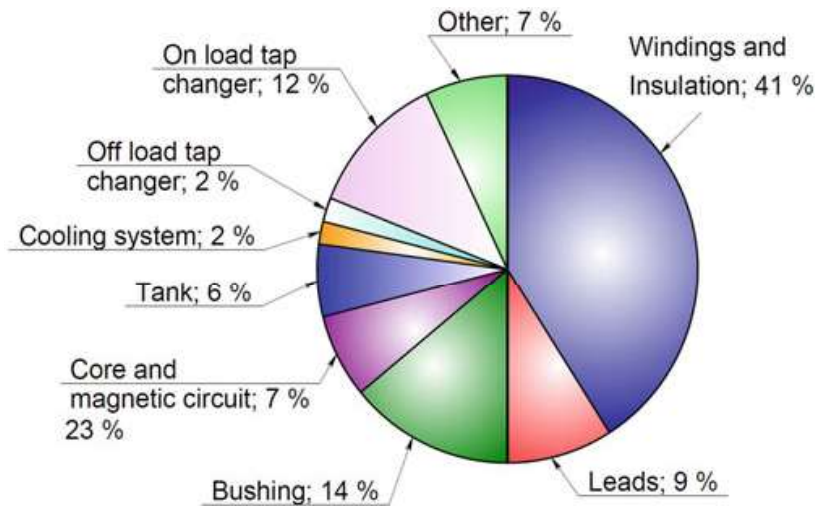
Fig. 1.3 Failure statistics for power transformers [1]

The next group under study included general-purpose 10/0.4 kV transformers of capacity between 10 and 630 kVA, with natural oil cooling and with a switch without excitation, connected to an alternating current network with a frequency of 50 Hz and intended for power transmission and distribution in moderate and cold climate. Analysis of problem-related situations involving 401 units of 10/0.4 kV 10/(10–630 kVA) power transformers taken out for repair revealed the following: mechanical displacements are responsible for 100 cases, turn-to-turn short circuit explain 74 cases, other defects (oil leakage, switch and contact connection issues, destruction of bushings, burnout of tightening pins) comprise 227 cases. In percentage terms, the result of analysis for 10/0.4 kV transformers is shown in Fig. 1.3 and Table 1.1.

Analysis of the data in Fig. 1.3 and Table 1.1 shows the following:

1. Winding defects account for 43% of the total number of incidents.
2. Mechanical displacements prevail among the winding defects and comprises 25% of the cases; turn-to-turn short circuits in one or both of the windings are responsible for 18% of the incidents in the total number of damaged transformers.

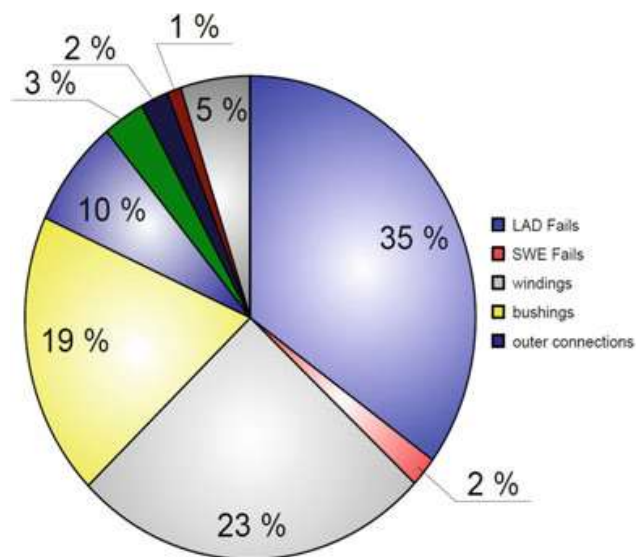
Fig. 1.5 Distribution diagram for transformer defects (Poland)

Analysis of the causes of identified internal damage showed that the most frequent defects of 110 kV transformers in Poland were due to local heating of the core and winding, internal short circuits, and simultaneous influence of several types of internal defects [4]. The share of different types of damage is shown in Fig. 1.5 (statistics for 22 years).

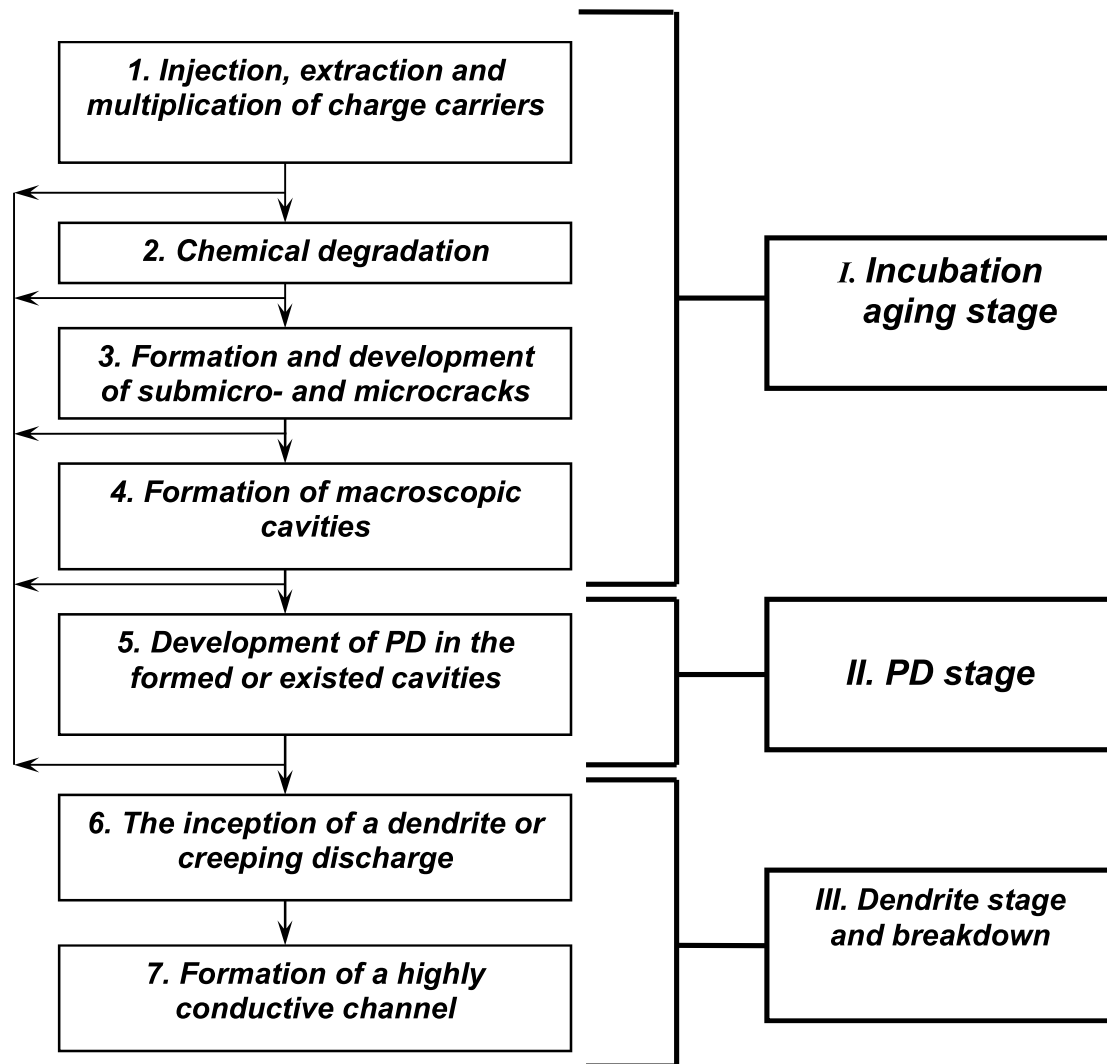
Fig. 1.8 Sequence and mutual influence of degradation processes for an insulating material in an electric field

The entire sequence of processes, from the formation of inhomogeneities (when they are absent at the initial state) to the breakdown of insulation, is shown in Fig. 1.8.

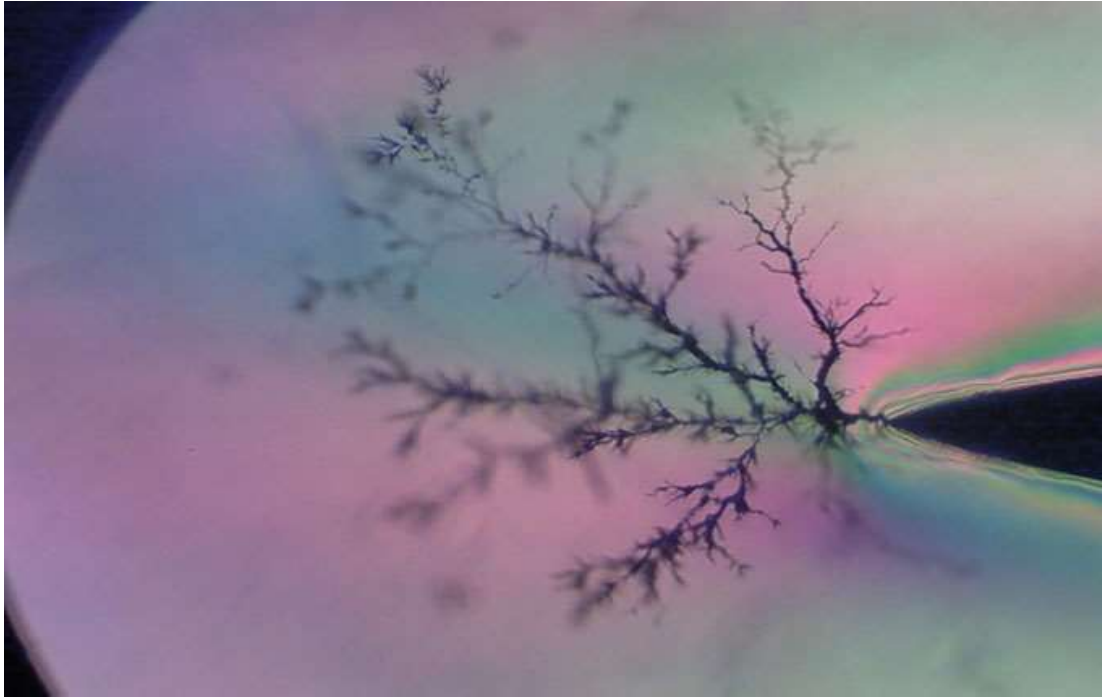
Fig. 1.9 Photo of a dendrite in a translucent polymer dielectric

Despite the fact that they develop in an environment, their plasma channels cause erosion and carburization of the surface layers in solid insulation, namely, the formation of conductive tracks. The tracks slowly penetrate the insulation and at some stage lead to the growth of a dendrite through the insulation. Dendrites and creeping discharges are shown in Fig. 1.9.

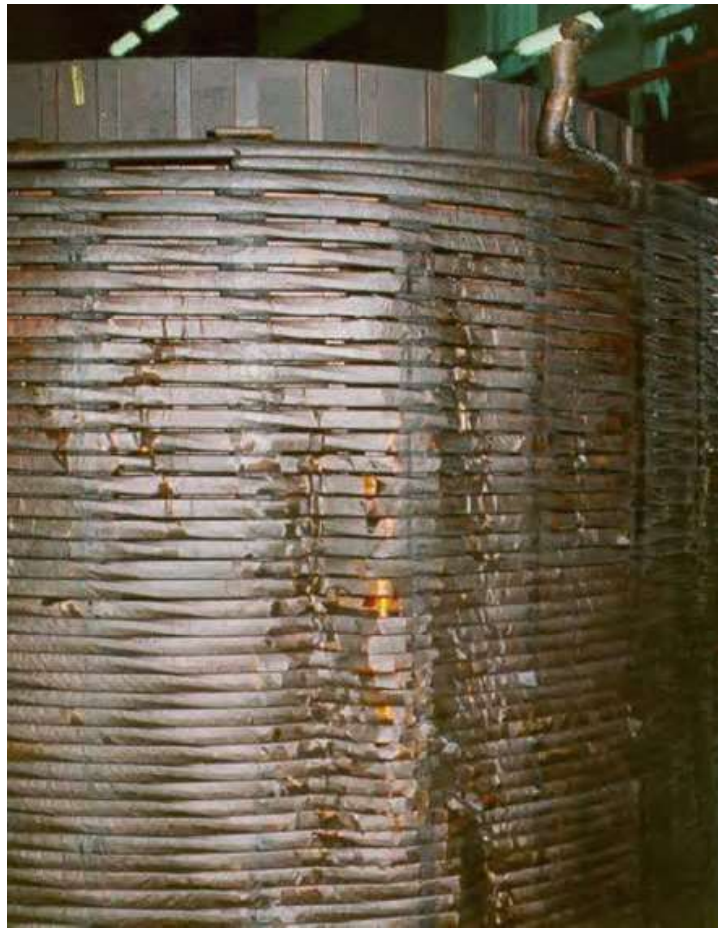
Fig. 1.13 Radial displacement of winding turns

Ponderomotive forces acting on a winding cause a radial displacement of the winding turns, Fig. 1.13, with a subsequent complex displacement of the turns, Fig. 1.14.

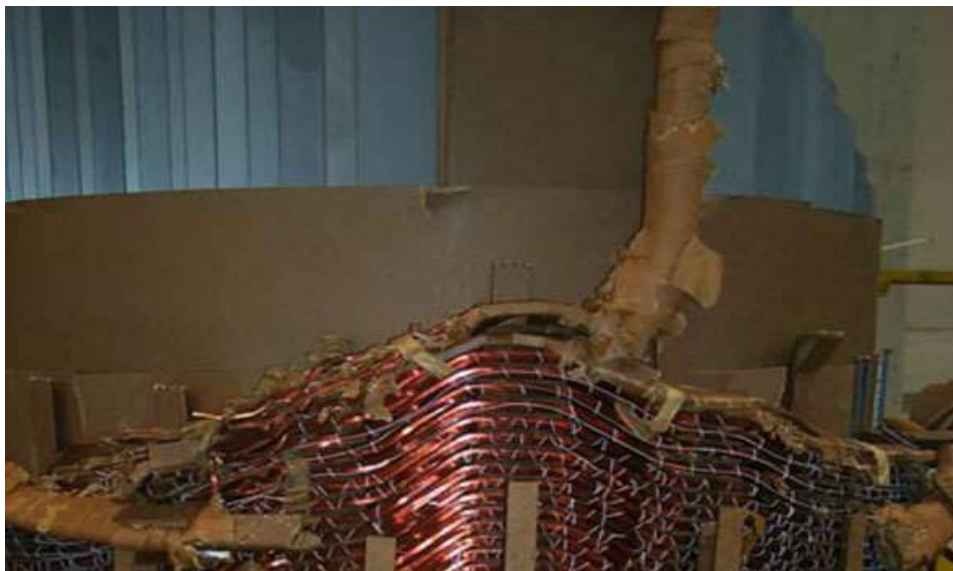
Fig. 1.14 Complex displacement of winding turns

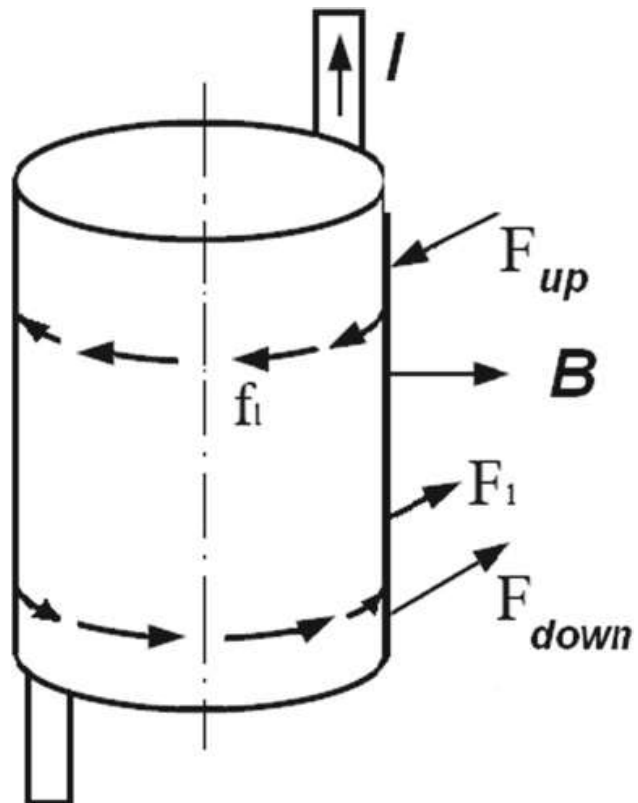
Fig. 1.15 Impact of tangential forces on a winding

Diagrams exemplifying the tangential effect of ponderomotive forces are shown in Fig. 1.15.

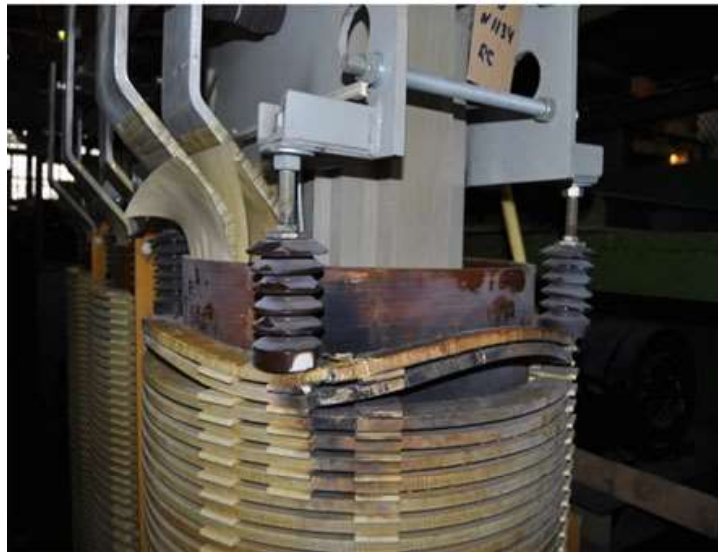
Fig. 1.16 Axial winding displacement

The tangential component of ponderomotive forces acting on a winding causes an axial displacement of winding turns, Fig. 1.16, with a subsequent defect of “lodging of conductors”, Fig. 1.17.

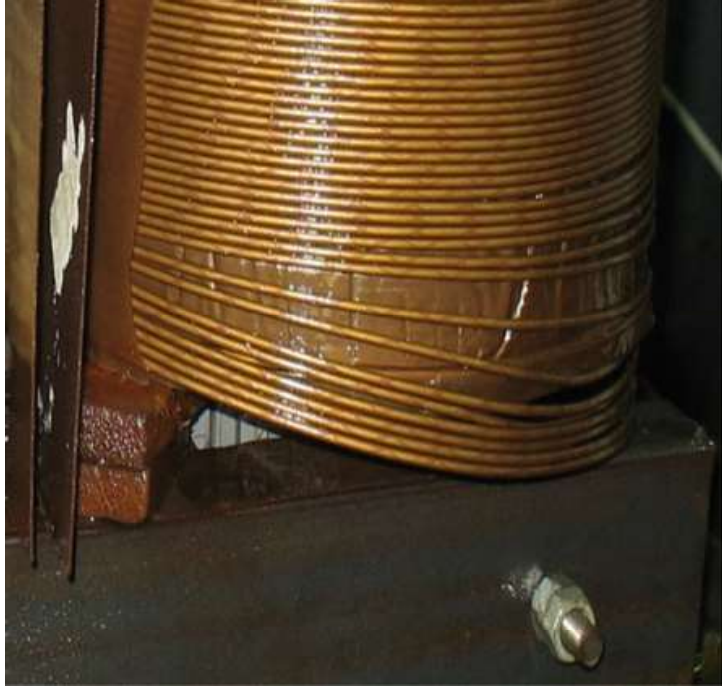
Fig. 1.17 Defect of the winding type “lodging of conductors”

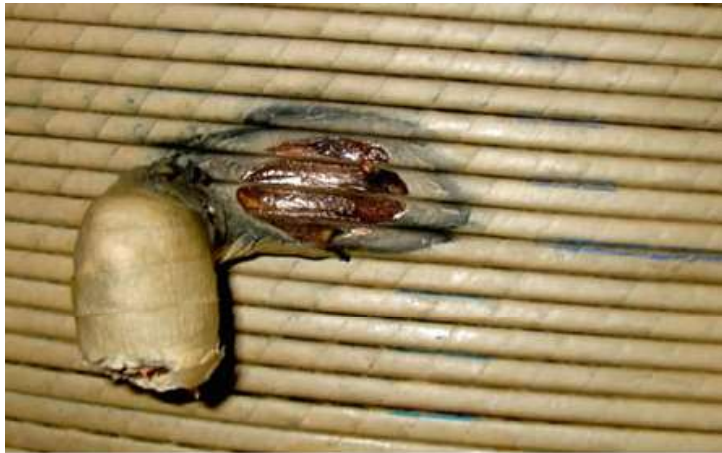
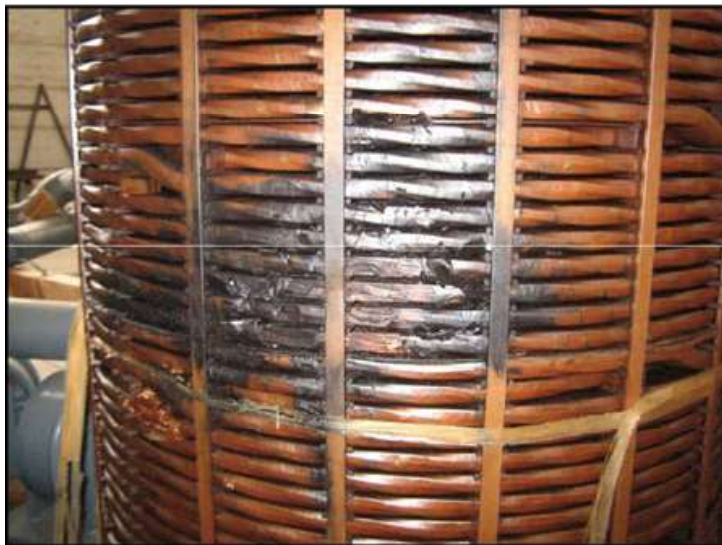
Fig. 1.18 “Short-circuited turn” type of winding defects

A defect of the “short-circuited turn” type occurs when the turn insulation is damaged by SC currents or switch over-voltages. The appearance of a “short-circuited turn” defect is shown in Fig. 1.18.
